# Manhole Inspection Summary

Manhole # S35WW1028MH

**Location** Address: **345 TUNBRIDGE RD**

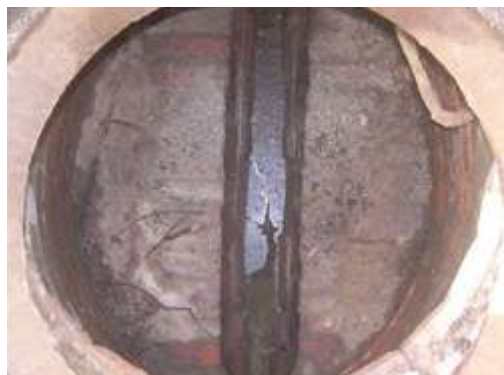
Top View

Corroded steps. Bench debris.

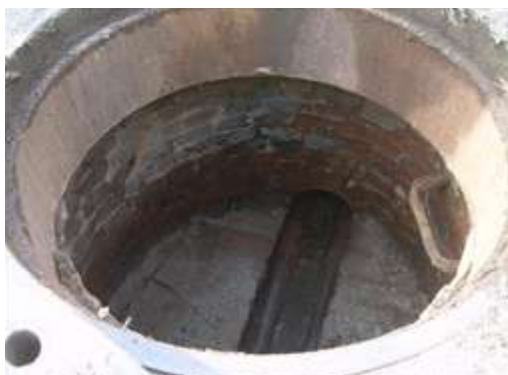
Defect

Frame leaks. Frame offset. Adjustment deterioration and infiltration. Corbel and Barrel infiltration.

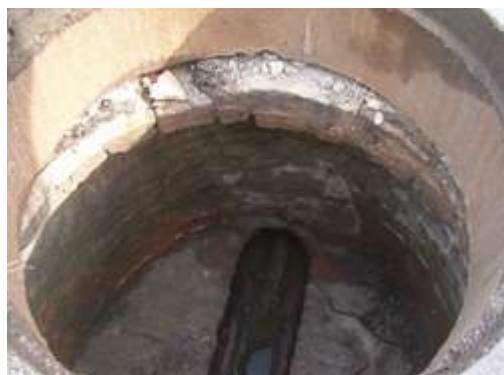
Defect

Frame leaks. Frame offset. Adjustment deterioration and infiltration. Corbel and Barrel infiltration.

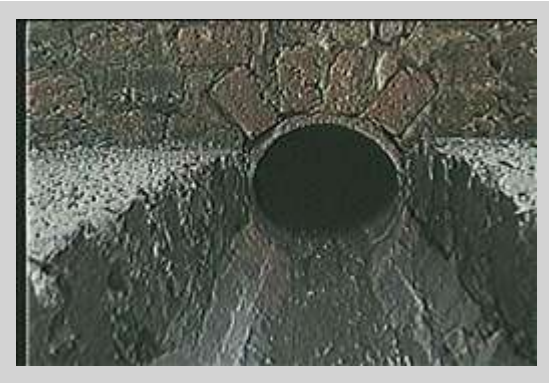
### 8 in. Circular Gravity Sewer Pipe Out @ 12 O'Clock

Barrel deterioration and infiltration. Channel deterioration.

Deposits: ☐ None ☒ **Mud** ☐ Sludge ☒ **Debris** ☐ Grease

Silt Depth: **0.5** (in.) Deposits Extent: **Light**

Infiltration: **Evidence** Pipe Seal Cond: **Unknown**

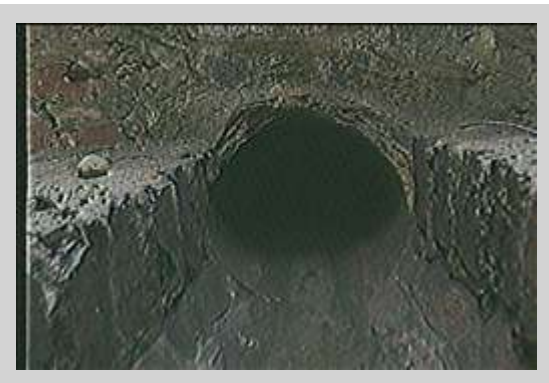
### 8 in. Circular Gravity Sewer Pipe In @ 6 O'Clock

Deposits: ☐ None ☒ **Mud** ☐ Sludge ☒ **Debris** ☐ Grease

Silt Depth: **0.5** (in.) Deposits Extent: **Light**

Infiltration: **Evidence** Pipe Seal Cond: **Unknown**
